2006/2007 Annual Inspection Report

SEDIMENT TRAPPING AT THE JAWS PROJECT (TV-15)

State Project Number TV-15 Priority Project List 9

June 22, 2007 Vermilion Parish

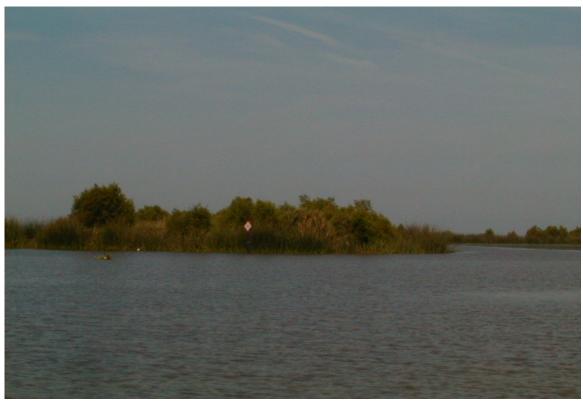
Photo 1—typical terrace and warning sign

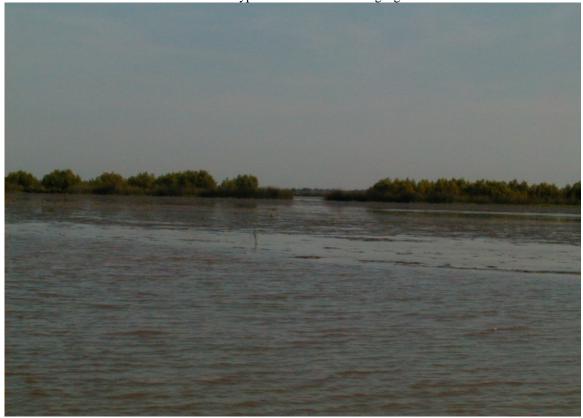
Photo 2—vegetated terrace and submerged aquatics

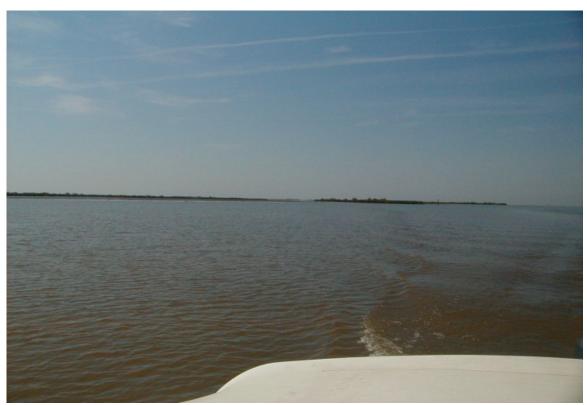
Photo 3—view of terraces from the south

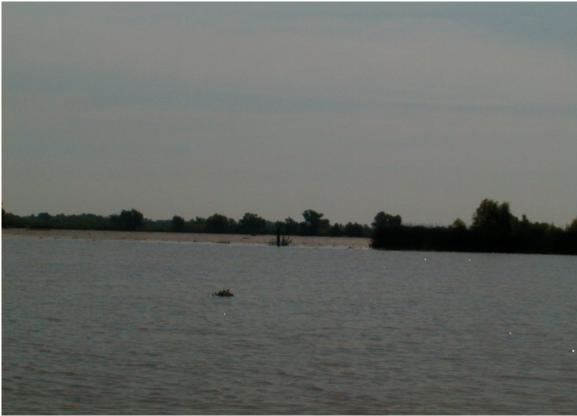
Photo 4—view of terraces showing accretion/vegetation between terraces
